Pentium® II Processor Specification Update

Release Date: December 1999

Order Number: 243337-032

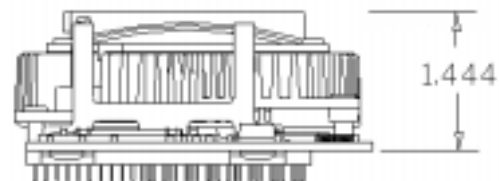
Bottom Cover Markings

- PODP66X333 = Product Code.
- SYYYY = S-spec Number.
- VW.W = Version Number.

1. Attached fan heat sink is not end user removable.
2. Fan power is provided through external fan power connector, not through the processor socket.
